Survey Report for Aravinda de Silva
“Casablanca”
1990 Com-Pac Yachts 27ft
Andrews Marine Surveying
File # 03222
9/30/2020

Marine Survey Report

File #: 03222 Date of Report: 9-30-2020 Date of Survey: 9-24-2020

Vessel Name: "Casablanca"

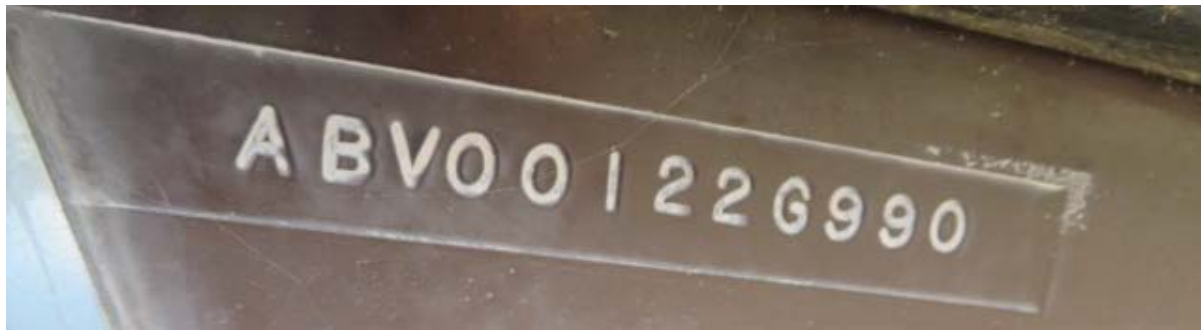
The hull identification number (HIN) was engraved on the vessel. The location of this number is in the upper, starboard corner of the transom. This number is required by the USCG on all vessels under 65-foot. A photo of the HIN was taken and is included in this report.
