Here are a few photos showing, to some degree hopefully, how the stringers are laid out in the Picnic Cat. The stringers serve two purposes, to add rigidity to the hull and provide support for the cockpit sole.

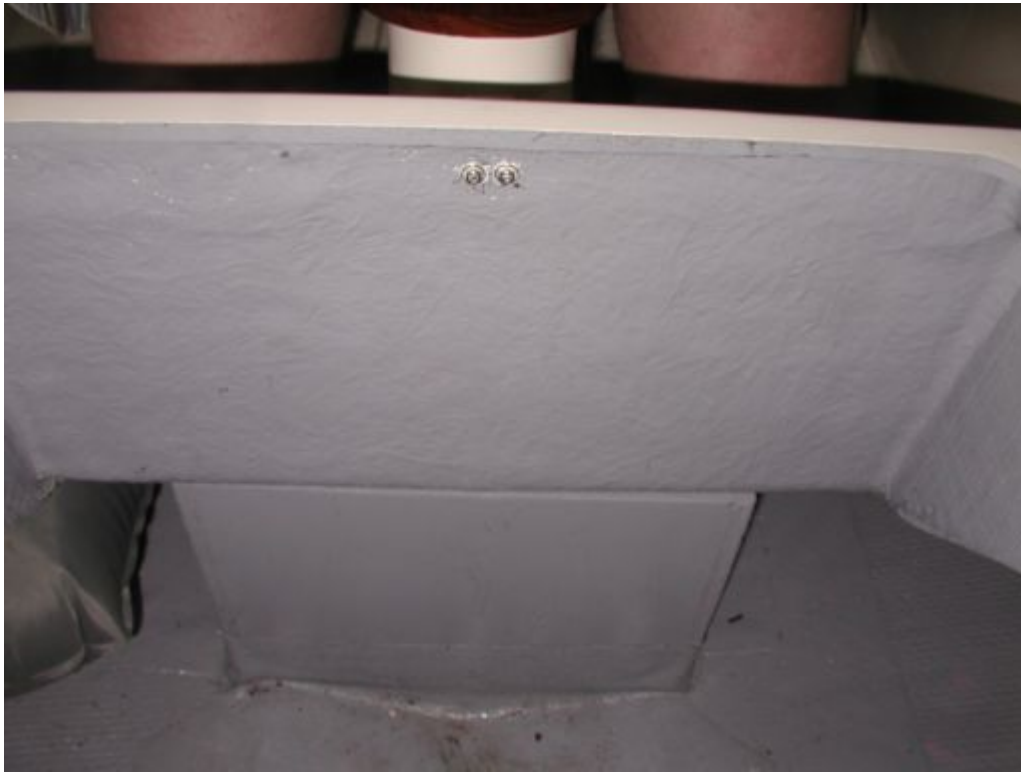
The first photo is probably familiar to most everyone. It's taken in the forward locker, looking aft. Under the forward bulkhead of the cockpit you can see the forward transverse stringer and the ends of the two longitudinal stringers. Note that the stringers are glassed to the hull, to provide the rigidity, but that the cockpit just rests on the stringers. No limber holes were observed.

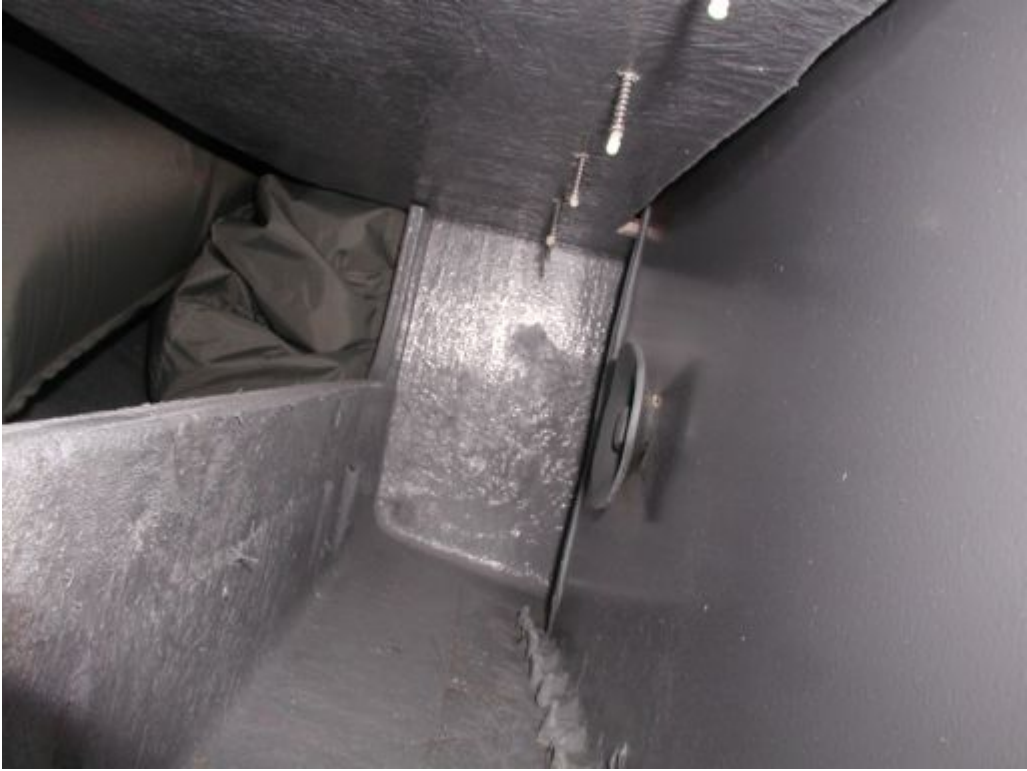
The next two photos were taken through the port locker. The camera was held next to the SS centerboard trunk, accessed through the cutout in the stringer. The first is facing forward (please pardon the list!). The CB pivot is seen on the SS trunk to the right. The port longitudinal and forward transverse stringers are glassed to the hull, and each other, with no limber holes. Fasteners from the cockpit CB trunk cover are seen at the top, as are those fastening the SS trunk to the hull at the bottom. An Optimist floatation bag, and the sail bag in the forward locker, are seen through the stringer cutout to the left.

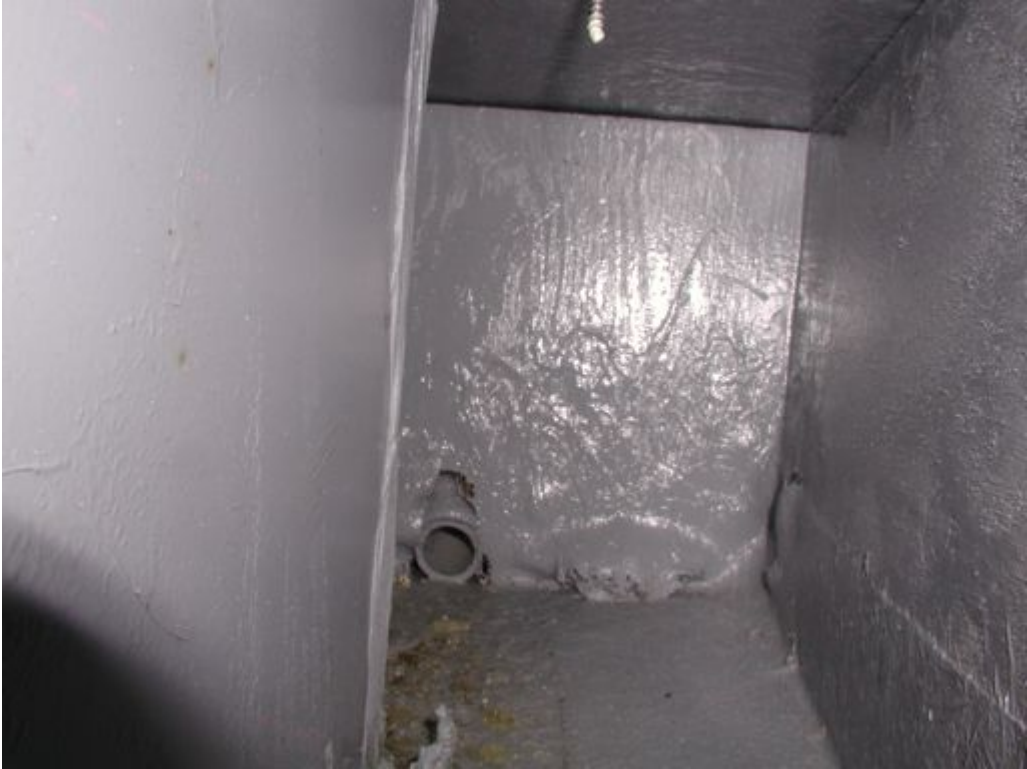
The following picture was taken from the same position next to the SS trunk, facing aft. A second transverse stringer is seen, glassed to the hull and the longitudinal stringer, the cockpit sole resting on top. Here we see a limber hole/drain.

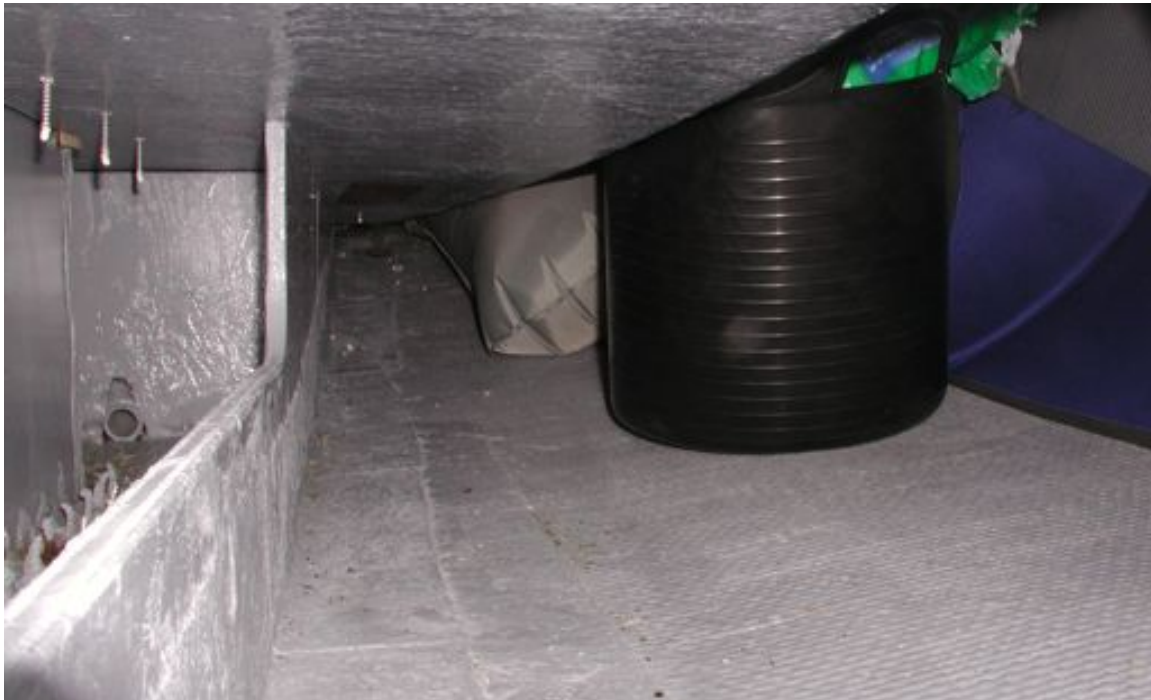
The fourth photo was taken near the preceding photo, but outboard of the stringer. Here the cutout is the evident, approximately half the height of the stringer at midships. Another Opti bag, and gear stored in the port locker.

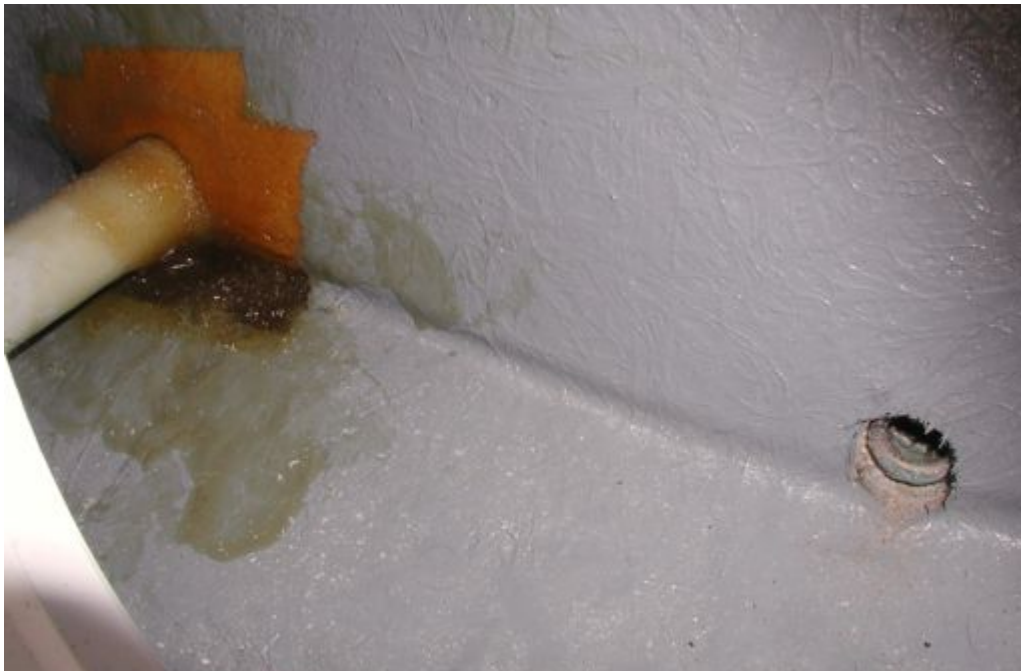
The next two photos are taken through the deck plate, under the teak bench in the aft bulkhead of the cockpit. The first is facing aft towards the transom. You can see the starboard cockpit drain to the left, and the bronze through hull to the right.

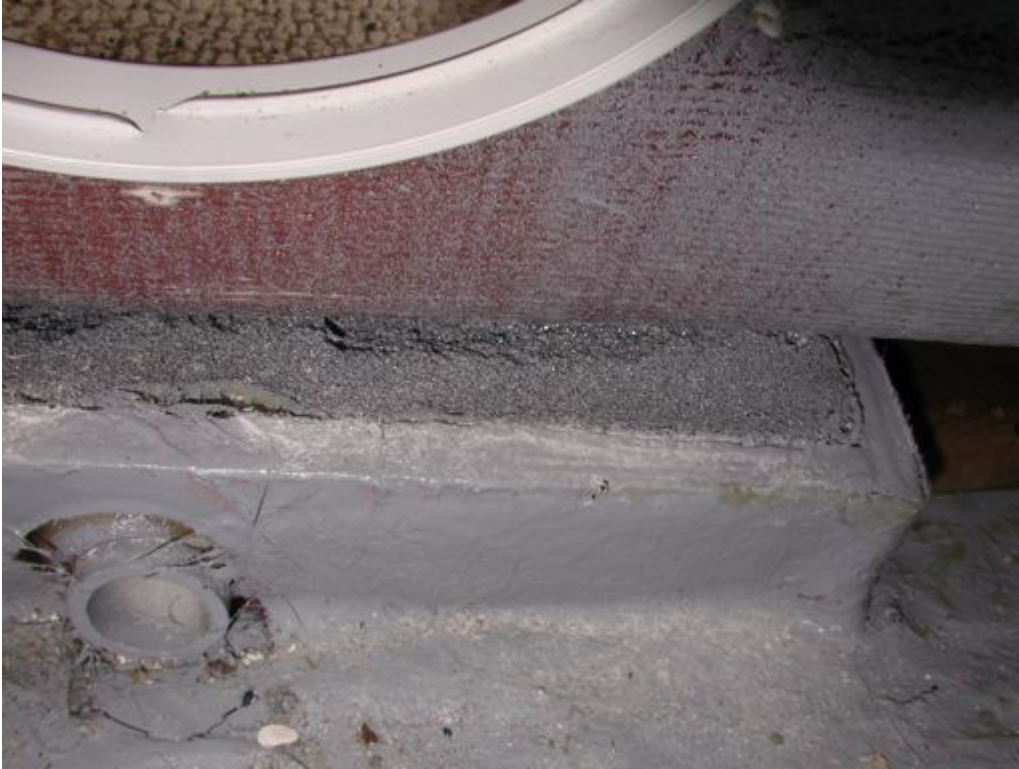
The last photo is facing forward, and we see the aft end of the stringer box, with a short transverse stringer glassed in place and the drain leading forward. Note also that it appears that the stringer box is filled with foam, further sealing the stringers to the hull, and providing some floatation. When I look back at the third photo, of the second transverse stringer, I believe I can see foam around the drain pipe there as well.

This could be helpful in tracking down the source of a leak. If the stringers are well sealed to the hull, and, until the water level reaches the height of the cutouts, the drain in the stringers the only way water can pass in and out of the stringer box, by temporarily plugging the drain should isolate the source to some extent. Water inside the stringer box would have to have come up from the SS trunk/hull flange, or from above through the CB cover/cockpit sole joint, or possibly the CB pendant tube. Water from the mast stub, hawse pipe, or transom fittings, would not be able to get inside the stringer box, and would collect in the bilges outboard of the stringers.
